The Cam Brook, Midford

An Advisory Visit by the Wild trout Trust, March 2013

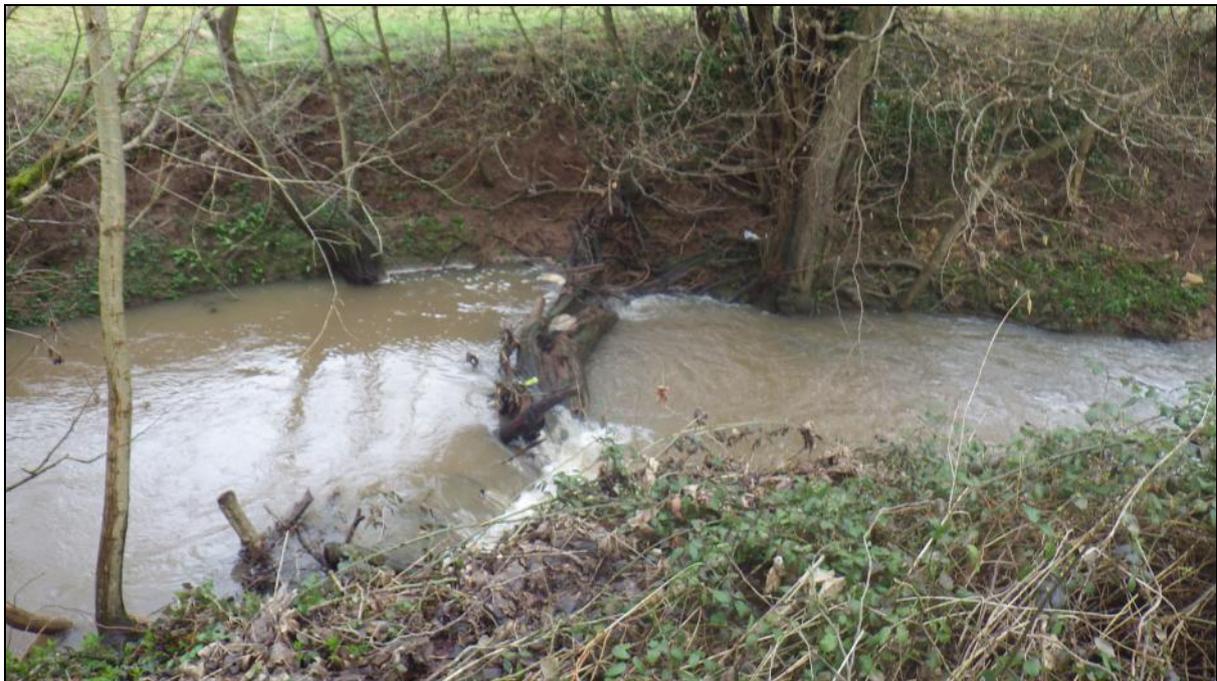
Figure 2: LWD providing habitat and helping to diversify local flow patterns

In places, woody debris has become lodged in the Cam Brook and created 'debris dams'. Debris dams across the river force flows underneath causing lateral scour to shape deep pools in the bed. A deep scour pool with overhead cover is prime territory for adult trout. The bed material thrown up by the scour will also be cleaned and sorted by the flows before being deposited a short distance downstream to create a glide or riffle, and potentially provide good spawning habitat.

Although providing important habitat, debris dams should be regularly assessed and monitored to ensure that they don't create issues for flood risk and fish passage. If a debris dam is considered to pose a flood risk, it may be prudent to dislodge the woody debris and reposition it so that it does not impound flows. Similarly, if the debris is impassable for fish it may be worthwhile adjusting the dam to ensure that a solid plume of water is flowing through the obstruction allowing fish to easily pass upstream. This could range from an occasional sympathetic relocation of the material to cutting and removing a section of the blockage.

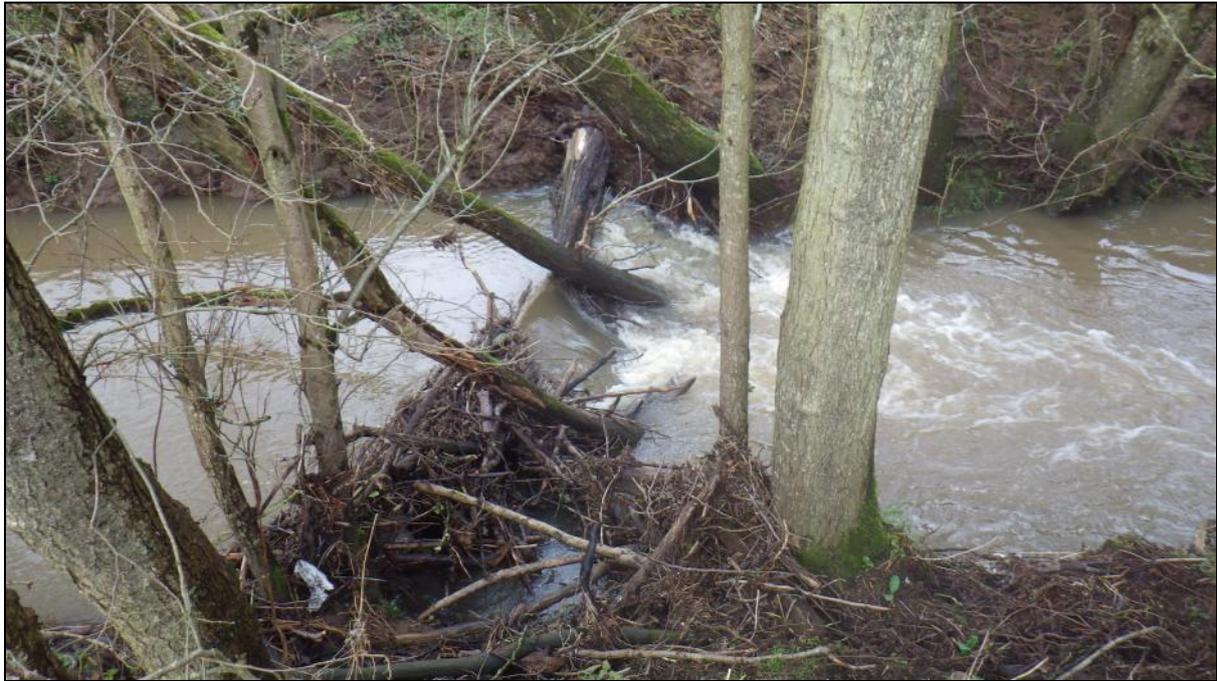
Fish have evolved to overcome natural barriers by following the fastest-flowing water. This will normally allow them to discover a path around, under, over or through a diffuse blockage. This flume of fast flow is known as the 'attracton flow' as fish are attracted towards it.

Figure 3: A debris dam should be passable so long as a solid flume of water is flowing through, over or under the blockage

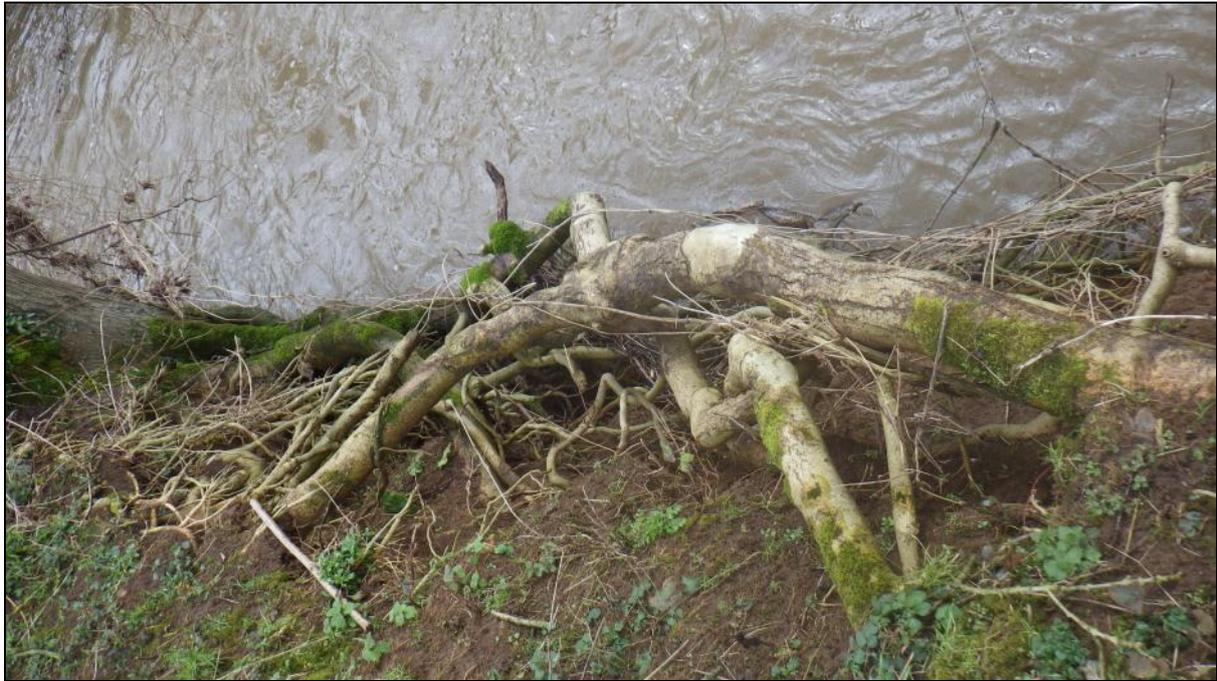
In many spate rivers, the flashy nature of the water level, combined with a naturally meandering course and steep banks, has led to problems with erosion. Fortunately for this section of the Cam Brook, the density of bankside trees provides a matrix of tree roots that help to reinforce the banks. In places this dense matrix of roots is clearly visible (Fig 4).

Figure 4: A dense matrix of roots in the steep banks helps to control bank erosion

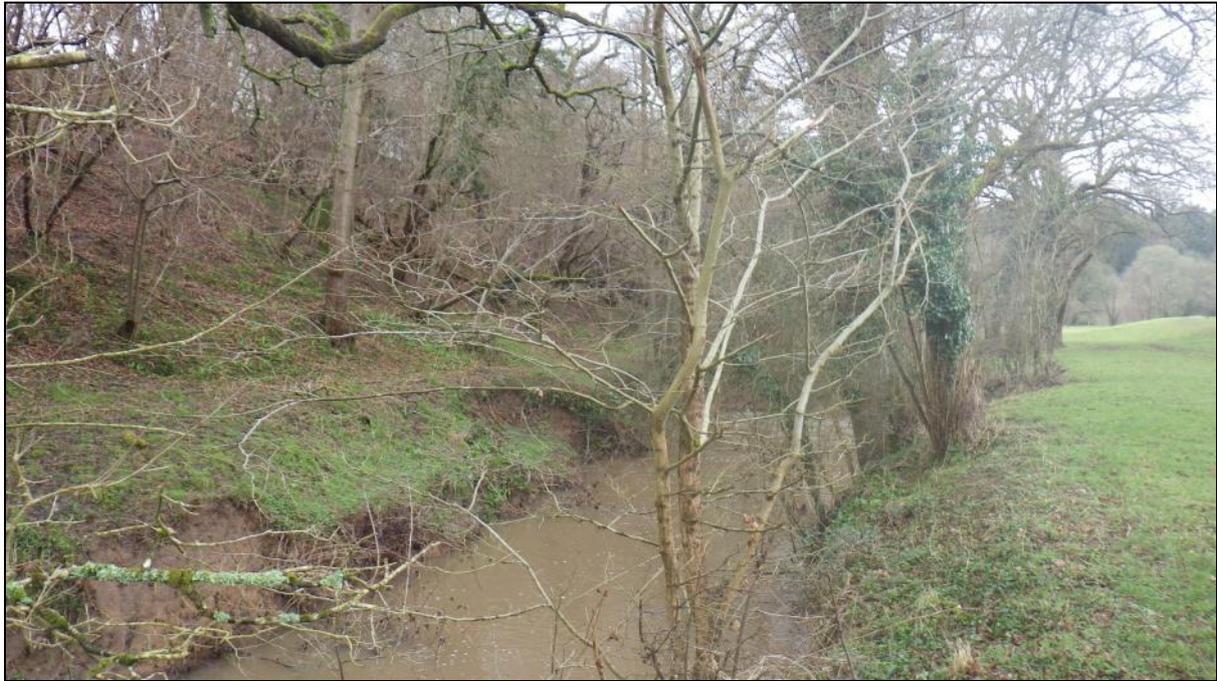
Downstream of the footbridge at ST 74851 60185, as the brook approaches the remains of the Somerset Coal Canal, the river becomes noticeably more straightened and flows roughly parallel to the derelict canal. The habitat through the straightened reach is more uniform than the river upstream and is heavily shaded, which is partly due to the steeply elevated and wooded land on the Right Bank (southern bank). As both banks are densely wooded, rotational tree works to allow more light into the channel would be beneficial.

Figure 5: The steeply rising ground on the right bank (left of image) and the dense tree cover will heavily shade the river in mid-summer.

Tree works will also help with angler access; however, it is important to note that low-lying and trailing branches provide important cover for trout, and that excessive clearing of the channel for improved casting could remove existing trout lies and may actually diminish angling opportunities.

Woody material arising from tree works could be used to mitigate the straightness of the channel and introduce a greater abundance of habitat features. Woody debris features and simple flow deflectors could be fixed to the bed to introduce lies for trout and help create more sinuous flow patterns through the reach.

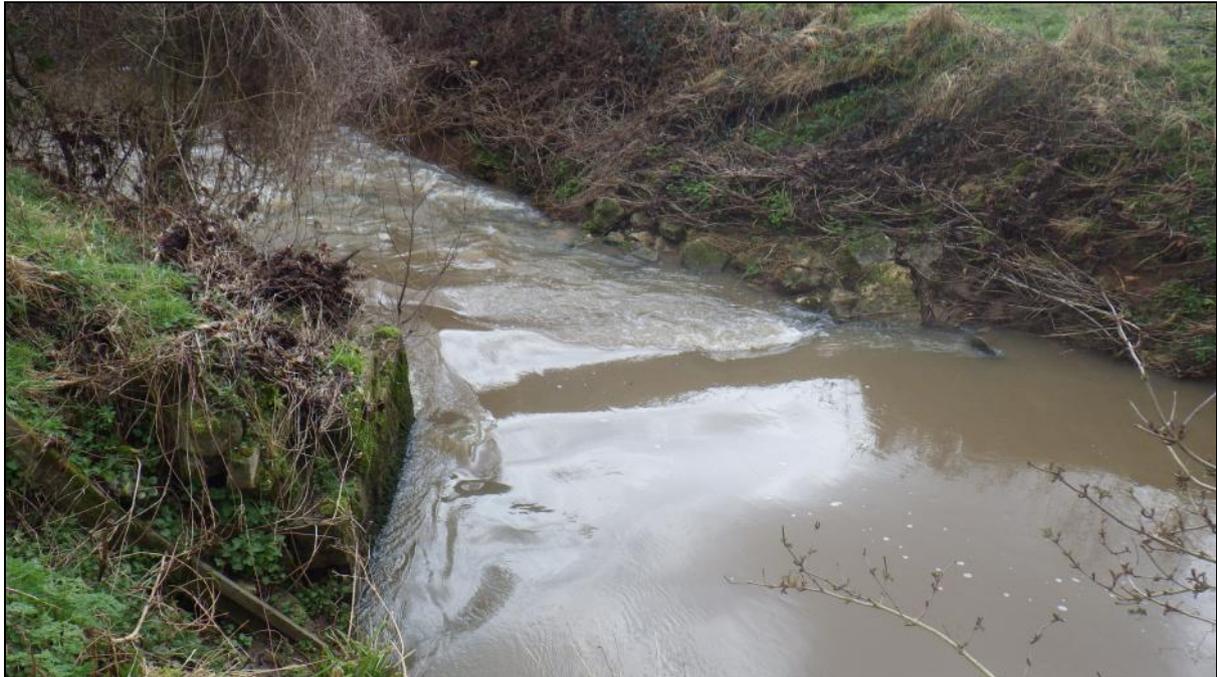
About half way through the straightened reach, the brook bends to the right and becomes slightly impounded by the remains of a weir. As the weir is dismantled, the effect of impoundment does not extend far upstream and the structure is passable to fish, so should not be considered a problem. The remnants of the structure pinch the channel and accelerate flows over rubble that is strewn across the bed downstream and probably originates from the weir. The remnants of the structures wing-walls have helped protect the banks and maintain the fast

flow. The accelerated flow has helped to initiate a series of pools and riffles through the reach downstream.

Figure 6: The remains of a weir or sluice structure slightly impound the river upstream but pinch the channel and accelerate flow velocity downstream

It appears this section of the brook was managed in the past by a series of small weirs or sluices, which are located through the reach downstream. It may be that pool depths were artificially elevated during dry periods, probably as part of the management regime when the river was a more intensively managed fishery; however, this is unlikely to have provided any real benefits and probably further degraded habitat within the reach by increasing the effect of their impoundment.

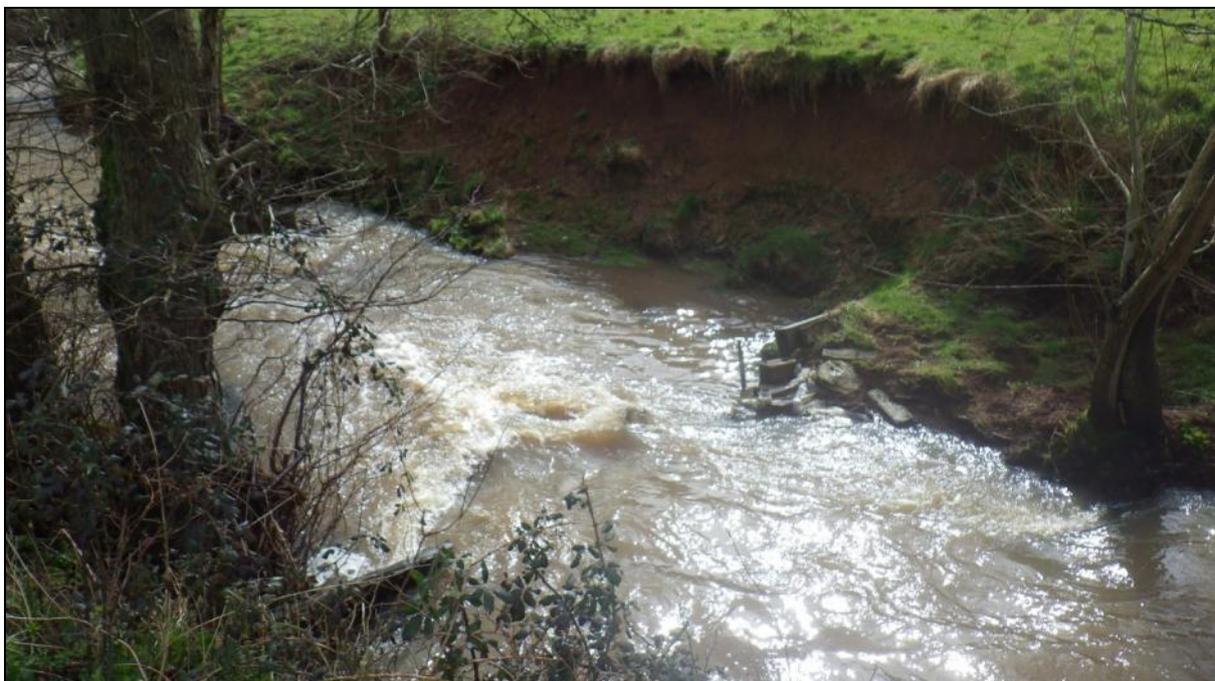
At ST 75304 60343 (Fig 7), a pinch point in the channel caused by one such structure appears to be exacerbating erosion. It is likely that under high-flow conditions, a back-eddy is formed against the Right Bank. The bank is below grazing land and is susceptible to erosion having very few trees or marginal plants to naturally reinforce the bank.

Figure 7: Bank erosion at this location may be the result of eddying flows and heavy grazing

Fencing the upper bank from grazing livestock and allowing a wide buffer of rough vegetation can help protect the banks from erosion. Rough grassland at the top of bank is valuable for fly life such as caddis (Trichoptera), and for mayflies (Ephemeroptera) as a habitat to hatch from sub-imago to adult form. A buffer of un-grazed grassland is also important for limiting soil compaction and creating a natural filter for surface water run-off. Ideally the river should be fully fenced wherever the adjacent land is grazed, but with occasional gates included to allow livestock into the buffer strip once or twice a year (if required) to help control invasive species such as Himalayan balsam (*Impatiens glandulifera*). It may also be worth considering planting occasional trees or driving in occasional whips of live willow to help protect the banks from erosion.

- Where erosion is considered to be a problem, a long piece of LWD can be fixed to the bed at the toe of the bank and the eroded bank protected by packing brushwood against the face sloping down towards the toe. This will slow water velocity across the slip and encourage deposition whilst also providing a habitat for small fish and invertebrates. If possible plant the slip with marginal species such as sedges (*Carex spp.*) to help stabilise the friable soil.

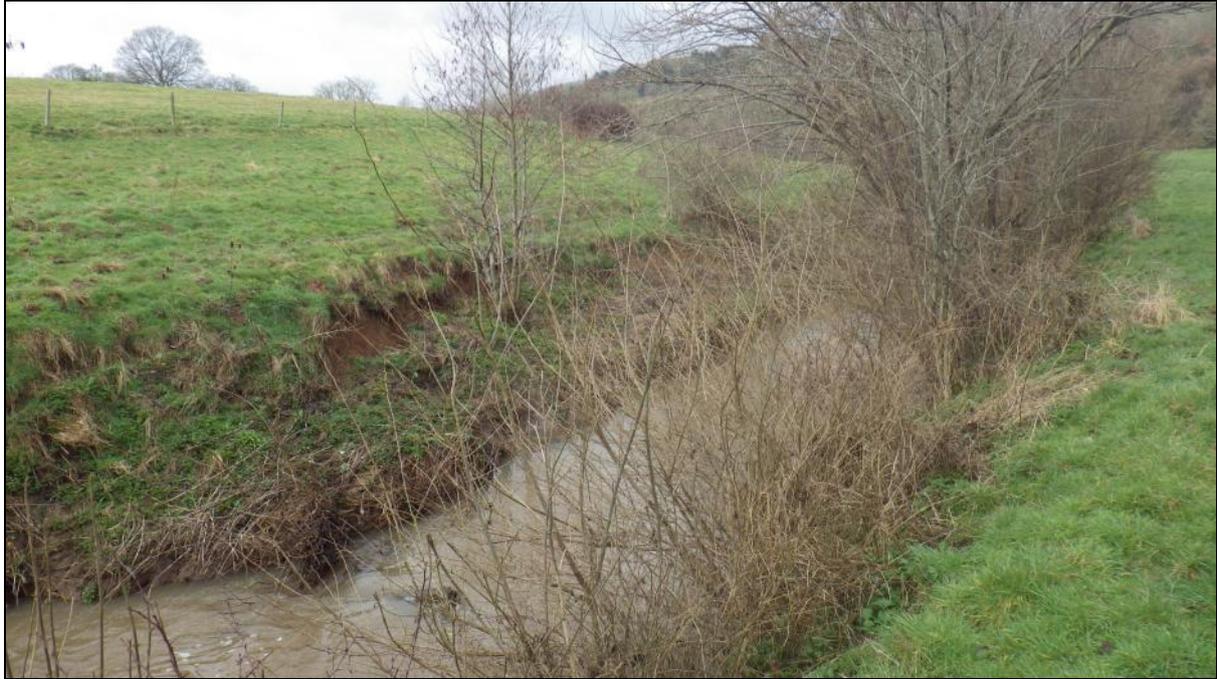
A short distance downstream, bank erosion at the toe of the bank has caused a rotational slump. The slumped bank has since stabilised and this has helped to reduce the gradient of the bank. Planting live willow into the slumped bank could help to ensure the bank remains stable. A low-growing species such as Goat Willow (*Salix caprea*) could introduce additional cover habitat for trout.

Figure 8: A rotational slump has stabilised and reduced the bank gradient

Where banks slump but do not immediately wash away, consider driving whips or stakes of live willow into the slumped area. If they successfully take root, the saplings will quickly help to hold the bank together. This technique is best undertaken during late winter/early spring when the willow is dormant, but can often be successful throughout the year.

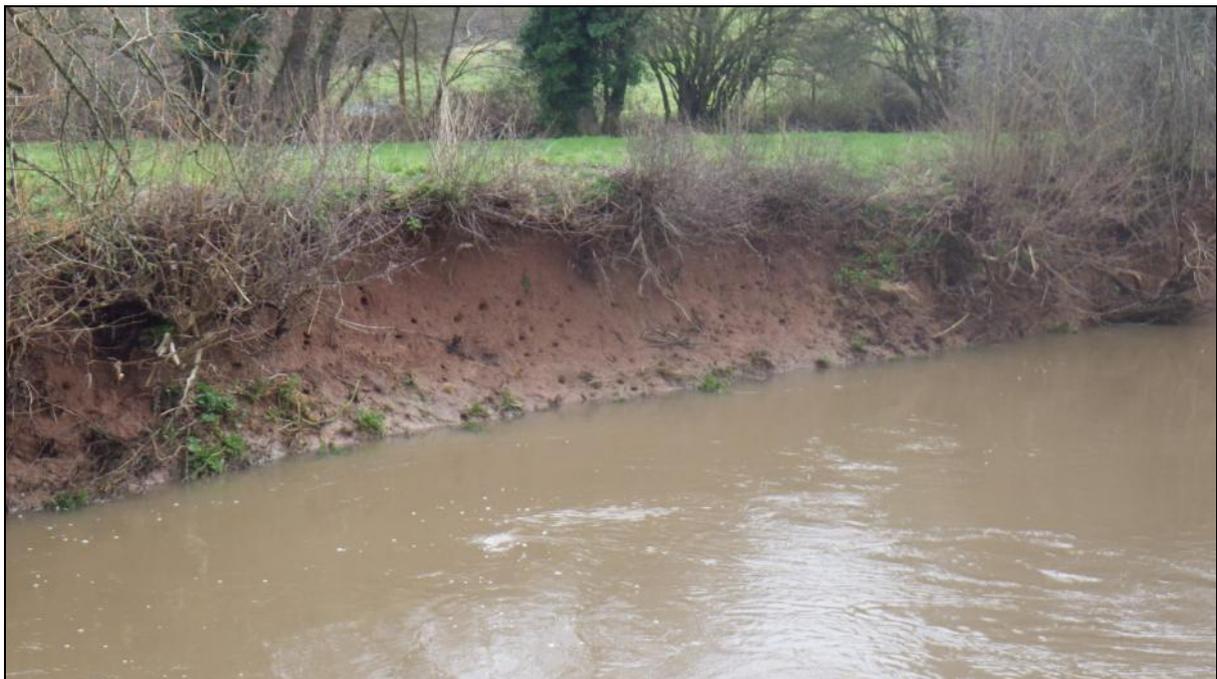
Downstream of the straightened reach the brook once again follows a more naturally meandering course and exhibits many classic spate river characteristics. The inside banks of meanders retain a generally shallower gradient whilst the outside banks have formed steep eroding cliffs that provide valuable habitat for sand martins (*Riparia riparia*).

Figure 9: A steep, cliffing bank provides habitat for sand martins

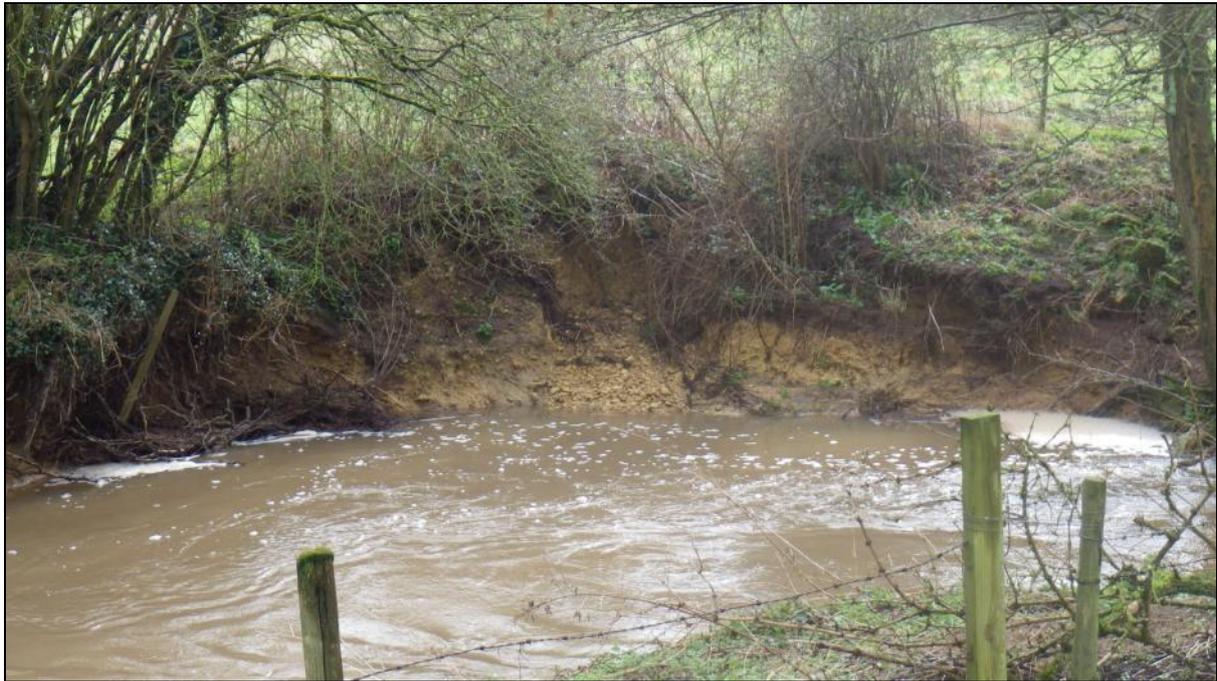
The erosion of the banks also introduces new sediment into the brook. Where the brook flows through seams of flint or oolitic limestone, a steady flow of coarse bed material (gravel) is introduced into the river.

Figure 10: A steady supply of oolite gravels are washed into the brook by bank erosion.

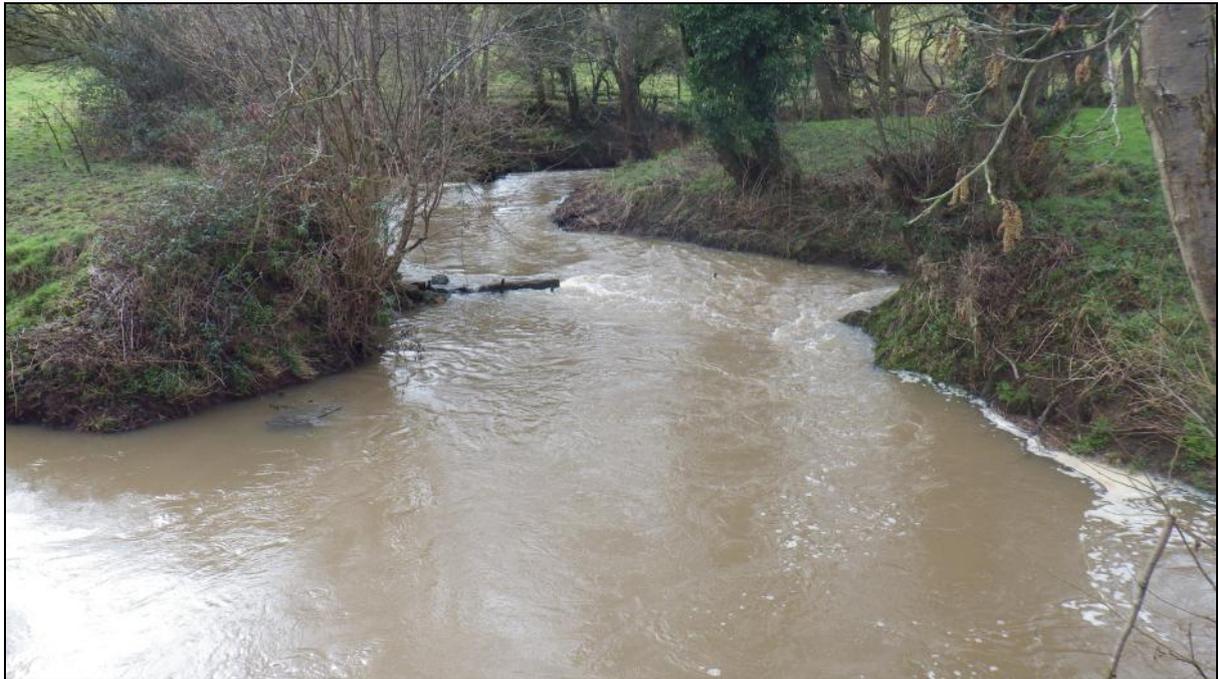
At ST 75520 60210 (Fig 12), groyne-like structures in the river appear to be the remains of small, semi-dismantled weirs, probably installed to impound flows for fishery management. The practice of impounding the river with a series of small weirs has historically been employed as a means of increasing holding capacity for large fish at the expense of spawning and juvenile habitat. This practice of artificially 'ponding' the river has particularly been used in heavily stocked fisheries where holding large fish for angling has been considered more important than retaining a sustainable wild population. The deterioration/demolition of these structures has helped the river to recover a more natural geomorphology that allows a natural pool-riffle sequence to establish. This has subsequently allowed better quality spawning and juvenile habitat to develop.

Where the remains of the weirs protrude into the channel, they act as flow deflectors, accelerating flows and increasing scour. The impact of the deflection may require further assessment to determine whether or not the structure should be left *in situ*, or whether it should be removed or repositioned. If concerns over bank erosion caused by the deflected flows outweigh the benefits of increased flow diversity and bed scour, it may be wise to adjust the structure

Figure 12: The remains of a small weir structure now acts as a flow deflector which increases habitat diversity but may be contributing to excessive bank erosion

or perhaps replace it with a more natural woody debris feature. Options to use woody debris for flow deflectors are explored in the *Recommendations* section.

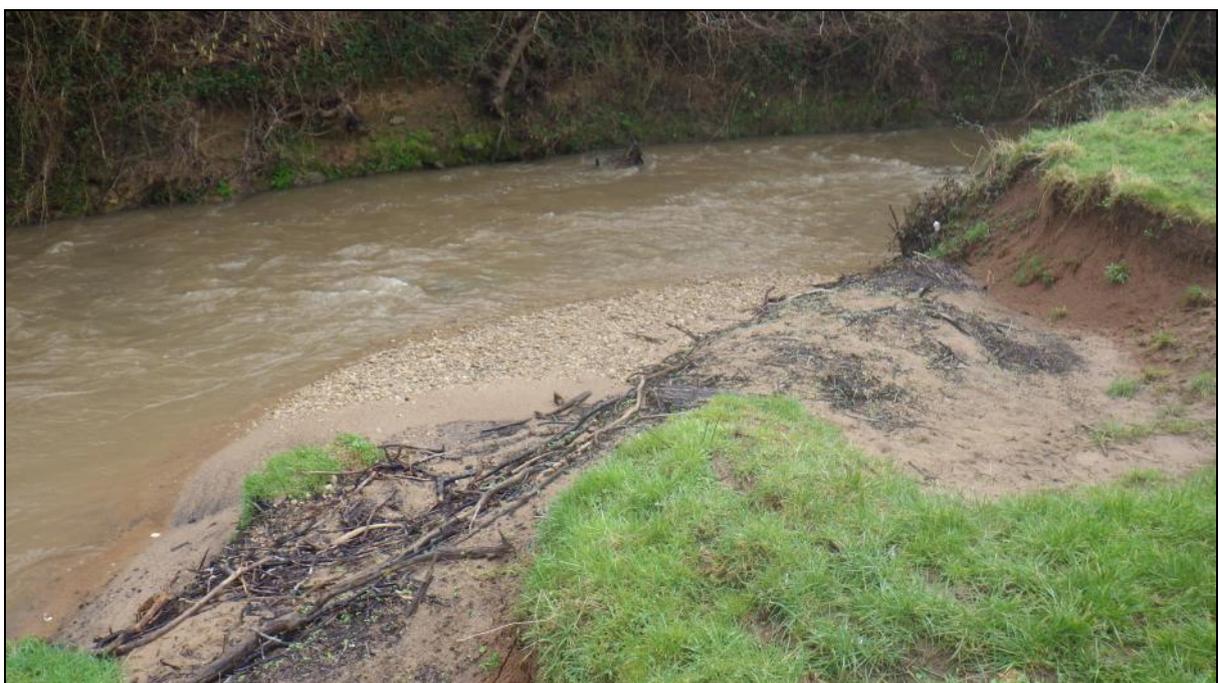
Where the brook is less incised, the shallow gradient of the banks on the inside of some meanders has allowed shoals of gravel to accumulate.

Figure 13: Gravel shoals collect at the insides of meanders providing potential spawning habitat

Ensuring that gravels are kept well-sorted and free from fine sediment will be vital for wild trout recruitment. In addition, identifying areas where trout spawn and focussing efforts to enhance the surrounding habitat for fry will also help to maximise juvenile survival. When fry first emerge from the gravel they are prey for a wide range of predators, including adult trout. Coarse woody debris (brushwood and trailing branches), dense root systems and beds of emergent vegetation provide vital refuges for trout fry. Even at this early stage, trout fry start to become territorial and will actively distance themselves from other fry. The volume of available refuge habitat is therefore extremely important in ensuring good natural recruitment. Studies suggest that 95% of juvenile trout perish before their first birthday, but accessible, varied habitat can produce profound changes to survival rates that are reflected in more three and four year-old fish that are of interest to anglers.

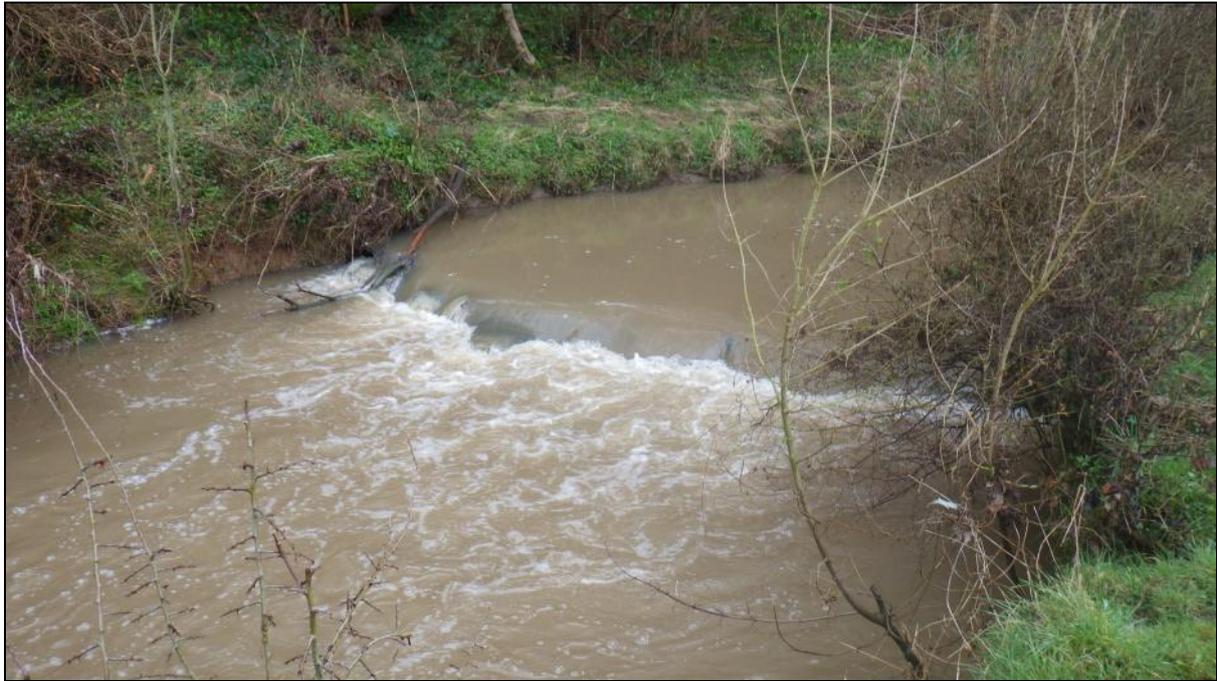
At ST 75692 60375 (Fig 14), a small weir is an intact example of the type of holding structures that have been dismantled upstream (Fig 6, Fig 7 & Fig 12). Although this structure may be to be a favourite spot for some of the club's anglers, the impounding effect on the water upstream is locally degrading the natural habitat. Impoundment structures interrupt the migration of gravels downstream, slow flows and allow fine sediment to accumulate on the bed. This results in a more uniform channel cross section and a reduction in habitat diversity. In addition, such structures can become barriers to fish movements during periods of low-flows and can fragment wild fish populations.

Figure 14: A small weir impounds flows and degrades the habitat upstream

Removing the structure and replacing it with paired deflectors to retain scour through the pool downstream will allow natural morphological processes to resume whilst still retaining good holding habitat for adult trout.
